Grace Baptist Church Inspection Report

Inspection Report

Concilio Iglesia de Dios Pentecostal

Property Address:
20 Demarest Avenue
Nanuet NY 10954

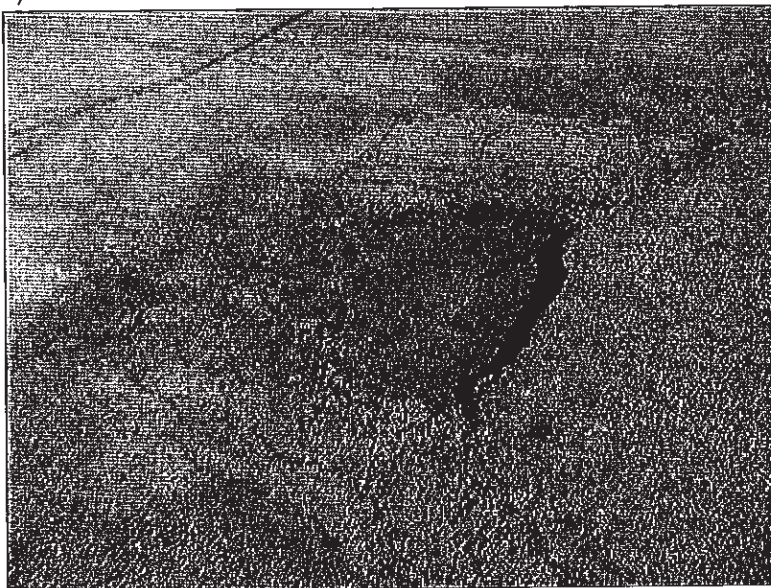
2.6 Damaged deteriorated asphalt parking area was noted at time of inspection. Repair / replace asphalt as needed.(Picture 1)(Picture 2)

2.6 Picture 1 damaged deteriorated asphalt

2.6 Picture 2 daamaged deteriorated asphalt

Damaged deteriorated asphalt parking area was noted at time of inspection. Repair / replace asphalt as needed.(Picture 1)(Picture 2)

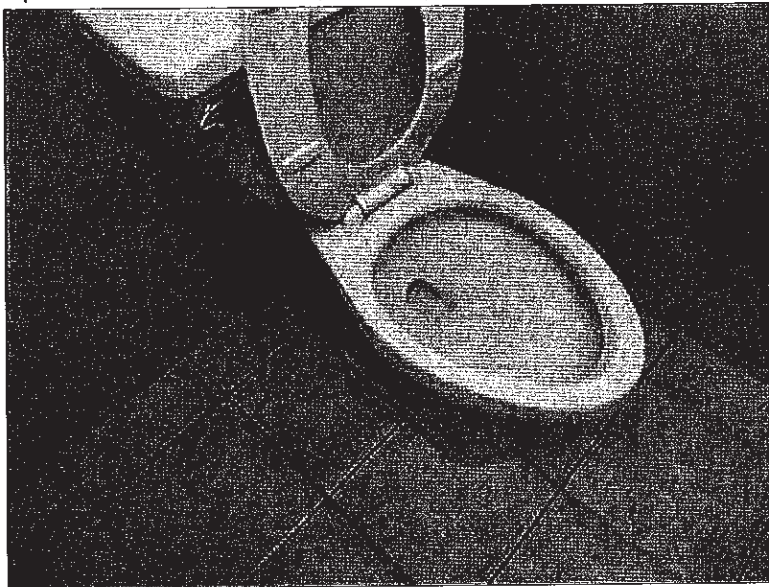
(2) The toilet is loose at floor at the bath. Repairs may involve re-setting the toilet on a new wax seal. I recommend a qualified licensed plumber repair or correct as needed.(Picture 3)

6.0 Picture 5 loose toilet

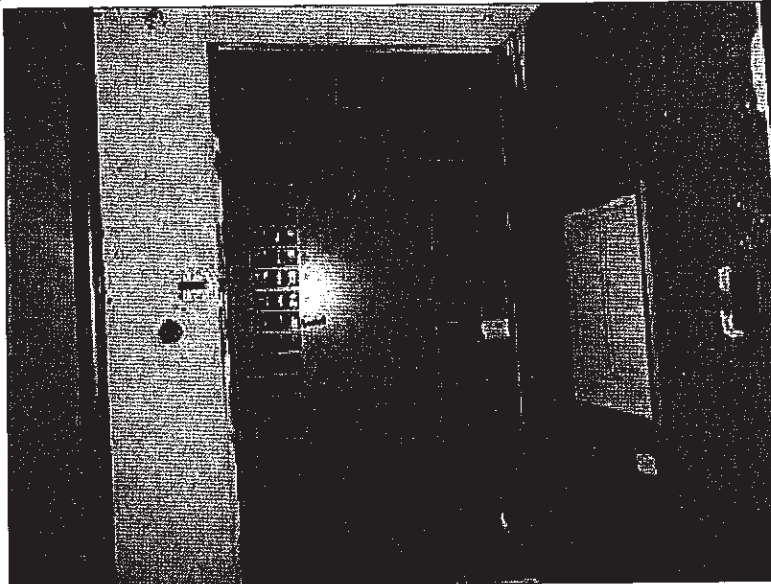
7.3 Older breakers and fuses was fuses were noted at time of inspection. Upgrade / replacements should be anticipated in future. Recommend having a licensed electrician further evaluate and replace as needed.(Picture 1)(Picture 2)

7.3 Picture 1 aged breakers

7.3 Picture 2 old fuses

Older breakers and fuses was fuses were noted at time of inspection. Upgrade / replacements should be anticipated in future. Recommend having a licensed electrician further evaluate and replace as needed.(Picture 1)(Picture 2)
